DEPARTMENT OF TRANSPORTATION**DIVISION OF ENGINEERING SERVICES**

Contract #: 04-0120F4Cty: SF/ALA Rte: 80 PM: 13.2/13.9File #: 69.28**WELDING INSPECTION REPORT****Resident Engineer:**Pursell, Gary**Address:** 333 Burma Road**City:** Oakland, CA 94607**Report No:** WIR-004767**Date Inspected:** 06-Nov-2008**Project Name:** SAS Superstructure**OSM Arrival Time:** 1330**Prime Contractor:** American Bridge/Fluor Enterprises, a JV**OSM Departure Time:** 2230**Contractor:** Zhenhua Port Machinery Company, Ltd (ZPMC), Changxing Island **Location:** Shanghai, China**CWI Name:** Mr. Liu Wei Wei**CWI Present:** Yes No**Inspected CWI report:** Yes No N/A**Rod Oven in Use:** Yes No N/A**Electrode to specification:** Yes No N/A**Weld Procedures Followed:** Yes No N/A**Qualified Welders:** Yes No N/A**Verified Joint Fit-up:** Yes No N/A**Approved Drawings:** Yes No N/A**Approved WPS:** Yes No N/A**Delayed / Cancelled:** Yes No N/A**Bridge No:** 34-0006**Component:** OBG Fabrication**Summary of Items Observed:**

OBG Bay #3

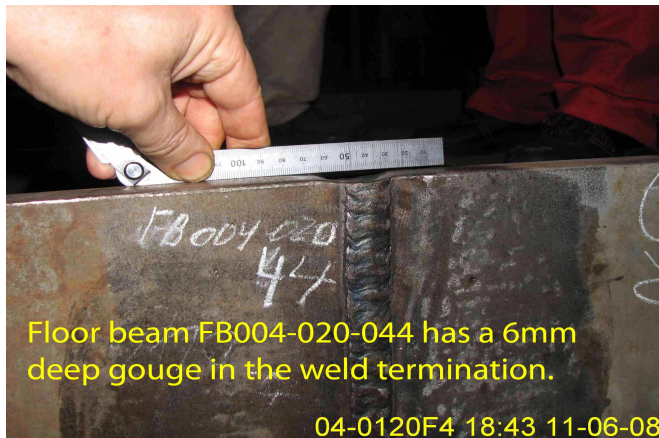
The QA Inspector observed Floor Beam weld FB004-020-044 has a 6mm deep gouge in the top termination (end) of this CJP weld. The QA Inspector informed CWI Mr. Liu Wei Wei who said he will have ZPMC add weld to the portions of the weld that is below flush. See the photograph below for additional information.
